Knuckle boom crane slew gearbox sleeve repair

Dive support vessel
UK

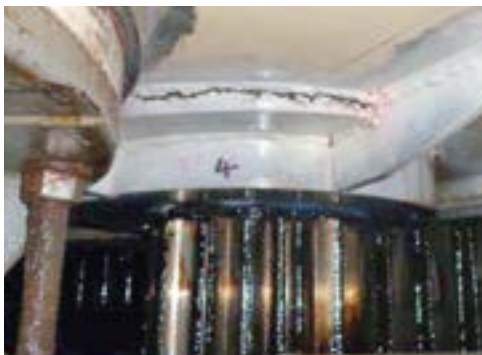
After discovering cracks in the weld connecting the four slew gearbox sleeves to the pedestal floor on their Hydramarine knuckle boom crane our client contracted us to identify the cause of the cracking and advise how it could be rectified.

- One of our design engineers was immediately mobilised to survey the crane, where they discovered that in addition to the cracking the gearbox sleeves were not adequately welded to the floor to allow them to resist the forces generated when slewing the crane.

- After further inspection we discovered the sleeves had only been welded by 270 degrees and to implement a full 360 degree weld at this point the crane would have to be removed or jacked up from the pedestal.

1. Initially identified floor cracks
2. Weld repair
3. Completed work

- To avoid the costly and time consuming exercise of deconstructing the crane we devised a plan to carry out the repair between the upper side of the crane floor and the gearbox sleeve rather than on the underside, where the weld was previously applied.

- The 360 degree welds were completed on all four gearbox sleeves and the cracks in the floor platework were repaired.
- Following weld completion all steelwork and box section was re-instated and all of the previously removed hydraulic, mechanical and electrical components were reinstated to the crane, before a load test was successfully completed.
