# Drill floor hydraulic system flushing to remove contamination

LOCATION North Sea

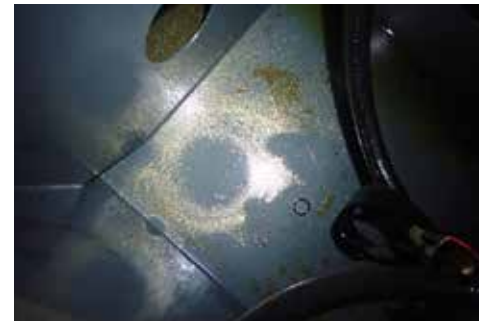
- Hydraulic oil from the system's reservoir was drained, allowing inspection of the reservoir. Metallic debris was identified at the base of the reservoir which was likely from the failed pump. On completion of the inspection, the reservoir was cleaned with lint free cloths, then sealed up with new gaskets to minimise contamination ingress

Drained reservoir before cleaning...

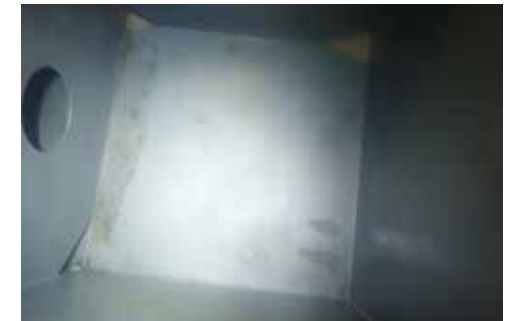
...and after cleaning.
