Project: Inspection and refurbishment of MLT 350SS crane boom

Location: UK

Date: 2015

CASE STUDY

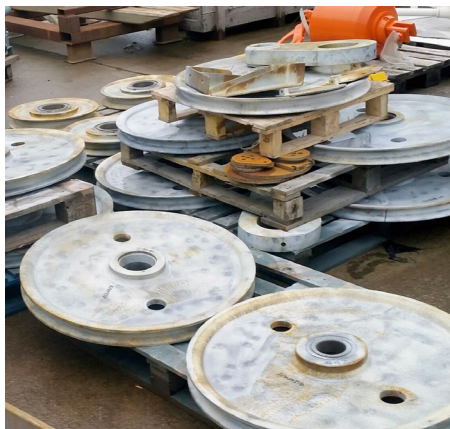
Blasted and inspected mechanicals

- The full strip down of all mechanicals and wash-down of all boom sections was carried out.
- All boom sections were then blasted to allow for inspection.
- Full NDT inspection was carried out, followed by MPI (magnetic particle inspection) of all the welds and UT (thickness checks) on the boom structure, sheaves, shafts and other ancillaries along with straightness checks on all chords.
- Full fabrication repairs and line boring of the boom sections were performed as per the anomalies identified from the NDT inspection.
- Full NDT inspection was subsequently carried out on repaired areas.
- All boom sections were blasted and coated to Sparrows SOS 401 at 350µm.
- All boom mechanicals were then fully assembled with sheaves, replacement fasteners, bearings and seals.

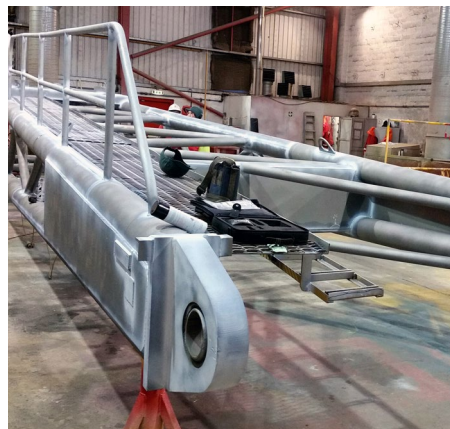
Root section undergoing inspection

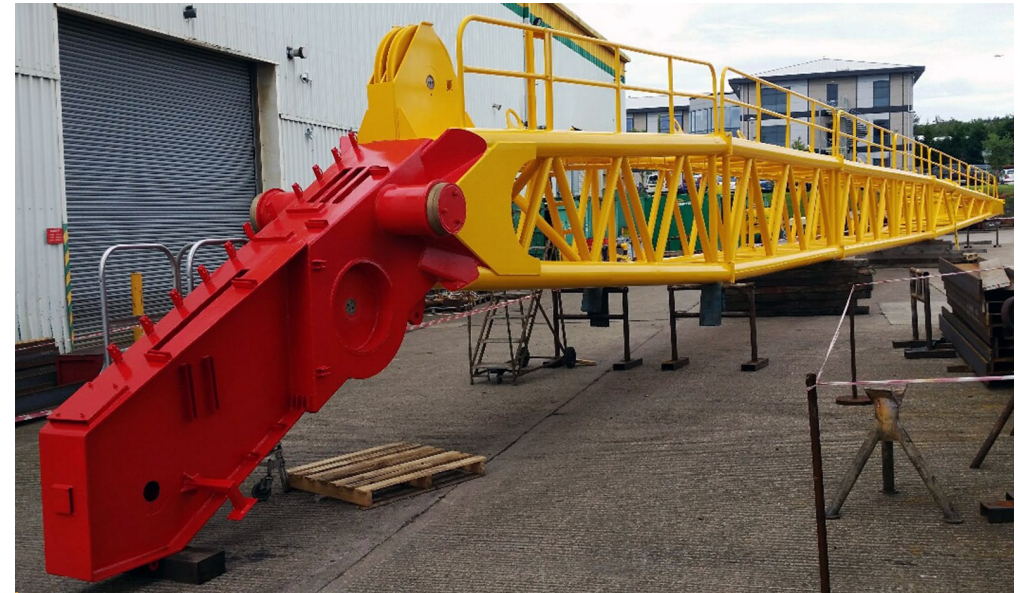
The refurbished and rebuilt boom

- Finally the complete boom was assembled for final inspection prior to offshore installation and load test.
- DNV reviewed, approved and witnessed the complete work scope performed and issued the relevant documentation.
