Asset: Dive support vessel
Project: Knuckle boom crane slew gearbox sleeve repair
Location: UK
Date: 2015

CASE STUDY

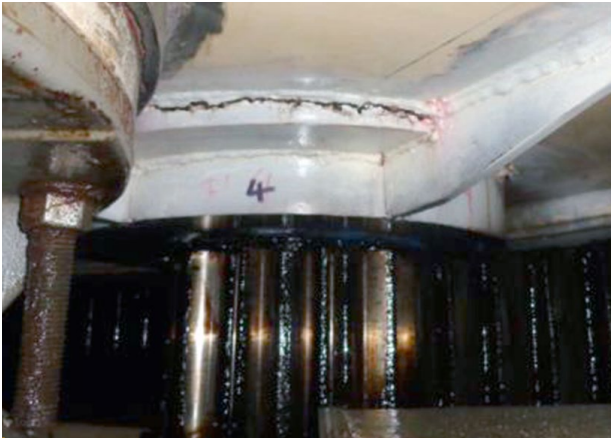
After discovering cracks in the weld connecting the four slew gearbox sleeves to the pedestal floor on their Hydramarine knuckle boom crane our client contracted us to identify the cause of the cracking and advise how it could be rectified.

- After further inspection we discovered the sleeves had only been welded by 270 degrees and to implement a full 360 degree weld at this point the crane would have to be removed or jacked up from the pedestal.

Initially identified floor cracks

- To avoid the costly and time consuming exercise of deconstructing the crane we devised a plan to carry out the repair between the upper side of the crane floor and the gearbox sleeve rather than on the underside, where the weld was previously applied.

- The 360 degree welds were completed on all four gearbox sleeves and the cracks in the floor platework were repaired.
- Following weld completion all steelwork and box section was re-instated and all of the previously removed hydraulic, mechanical and electrical components were reinstated to the crane, before a load test was successfully completed.

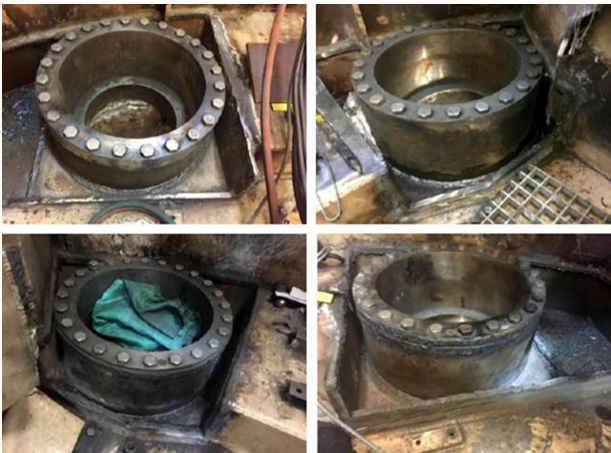
Weld repair

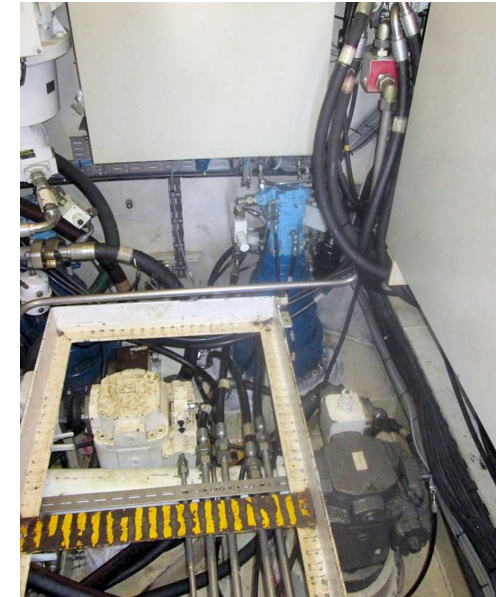
Completed work
