Refurbishment of two PCM 120 AS cranes

Jack-up drilling rig
Abu Dhabi

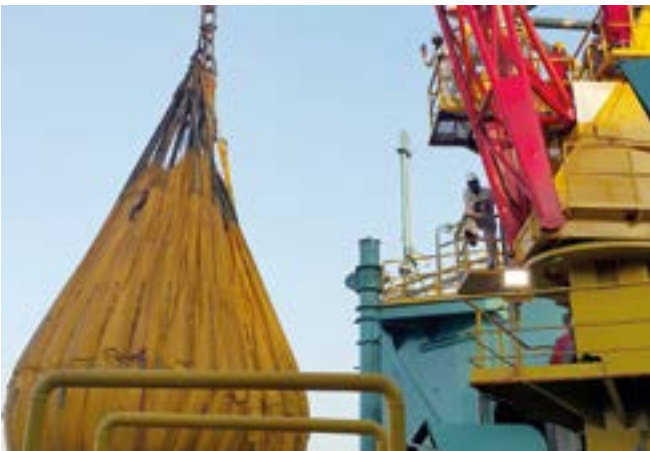
1.
Load test

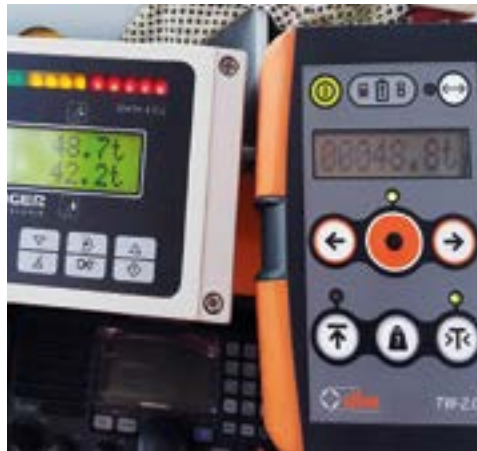
2.
Load test readings

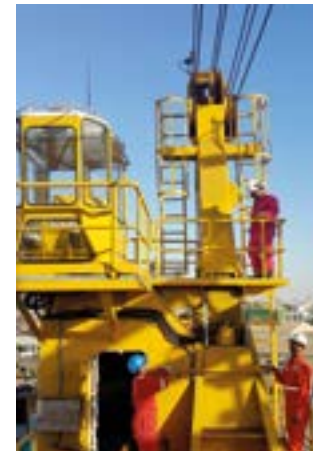
3.
Installation of refurbished crane
