Hydraulic retrofit for aft starboard capstan on diving support / well intervention vessel

CLIENT Helix Well Ops (UK) Limited
ASSETS MSV Seawell
LOCATION Aberdeen harbour, UK

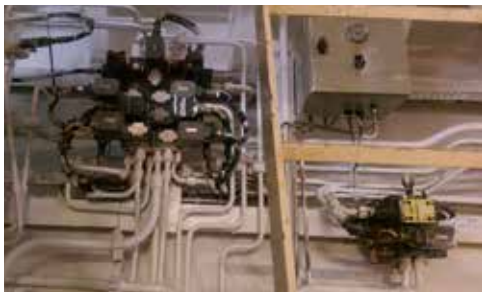
1. Control and brake release manifold pre-retrofit.
2. Brake manifold post-retrofit.
3. Control manifold post-retrofit.

- Replace cartridge valves in the hot oil strip manifold
 - Due to differences between the A4V250 and A4VG250 pump, retrofit new external boost filter
 - Remove the hydraulic control / brake release manifolds and send to our Aberdeen workshops for strip down, inspection, clean-up, replacement of valves / blank-off redundant and testing
