Knuckle boom crane slew gearbox sleeve repair

Dive support vessel
UK

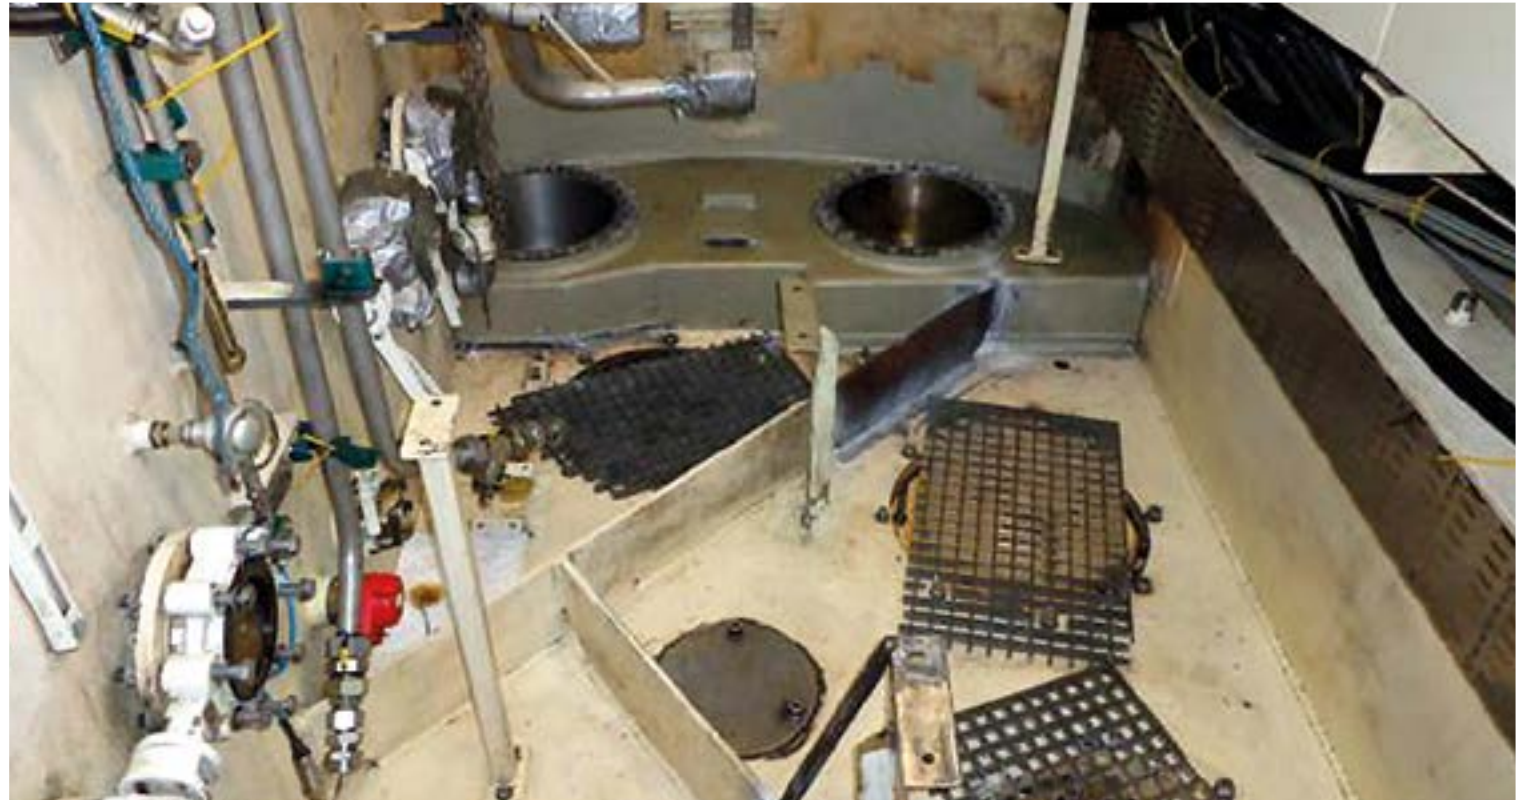
After discovering cracks in the weld connecting the four slew gearbox sleeves to the pedestal floor on their Hydramarine knuckle boom crane our client contracted us to identify the cause of the cracking and advise how it could be rectified.

- One of our design engineers was immediately mobilised to survey the crane, where they discovered that in addition to the cracking the gearbox sleeves were not adequately welded to the floor to allow them to resist the forces generated when slewing the crane.

- After further inspection we discovered the sleeves had only been welded by 270 degrees and to implement a full 360 degree weld at this point the crane would have to be removed or jacked up from the pedestal.

- To avoid the costly and time consuming exercise of deconstructing the crane we devised a plan to carry out the repair between the upper side of the crane floor and the gearbox sleeve rather than on the underside, where the weld was previously applied.

- The 360 degree welds were completed on all four gearbox sleeves and the cracks in the floor platework were repaired.
- Following weld completion all steelwork and box section was re-instated and all of the previously removed hydraulic, mechanical and electrical components were reinstated to the crane, before a load test was successfully completed.
