# Flushing and re-commissioning of fire pump hydraulic drive system

**ASSET** Floating Production, Storage and Offloading (FPSO) unit  
**LOCATION** UK

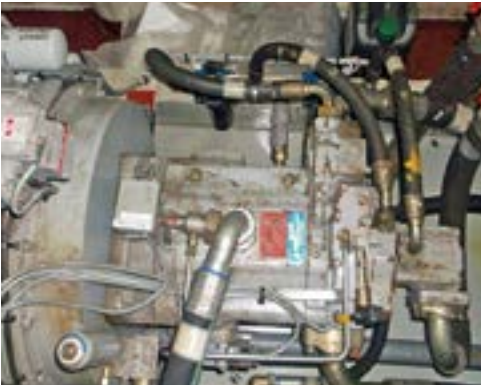
1.

- Two hydraulic technicians were mobilised to the FPSO with diagnostic and oil sampling equipment to carry out testing on the fire pump system.
  - High internal leakage in the hydraulic pump was identified as the reason for the drop in performance whilst debris was found in the hydraulic transmission lines.

Hydraulic transmission pump

- The hydraulic pump and motor were replaced and the system pipework was flushed to clean out the hydraulic reservoir which took 10 days.
  - Commissioning and testing were carried out.

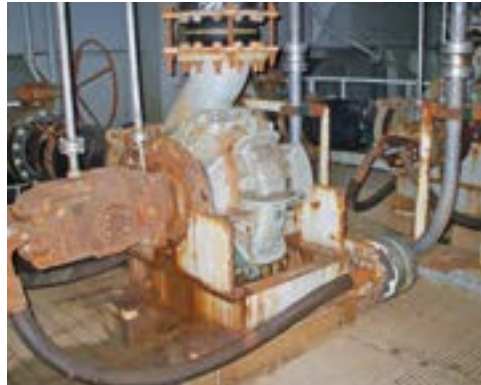
2.

Our client had been experiencing operational issues with the hydraulic drive system for the forward starboard fire pump on board their FPSO. Testing of the fire pump system had highlighted that hydraulic drive system performance was below specification, and when the system was operating under load, the hydraulic boost pressure would drop, causing the system to shut down.

Fire pump and hydraulic drive motor

- The root cause was found to be a control system problem which had been present since the system was originally installed
  - With the control issues rectified the system was flushed, commissioned and tested, and successfully returned to service.
