# Crane removal, refurbishment and reinstallation

**CLIENT** Spirit Energy  
**ASSET** DP6 / 8 platform  
**LOCATION** Morecambe bay, UK

Crane removal for full refurbishment removing structural, mechanical, electrical, hydraulic anomalies to extend operational life

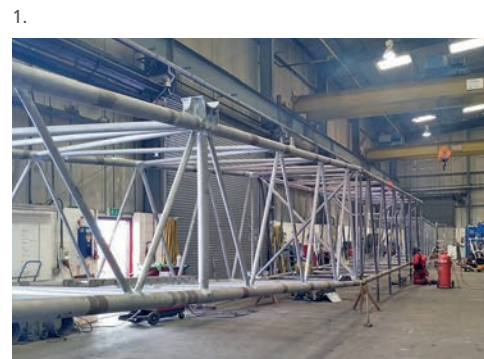
1. Full boom refurbishment.
2. DP8 crane being transported from Sparrows workshop to Aberdeen harbour.

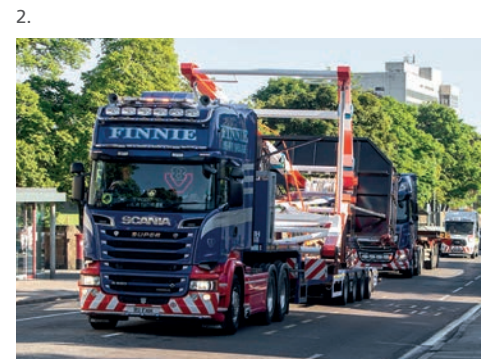
- Transporting the crane from Sparrows workshop to Aberdeen harbour required wide load notifications to be lodged with Police Scotland and the local authorities. The 10-week notification period was a critical aspect of the workscope and planning and execution had to be tightly monitored
